TRACTOR SERVICE INFO

INATractor FEAD clinic – John Deere 6520

FEAD belt kit replacement – step by step

This John Deere 6520 produced in 2004 has just over 8000 working hours.

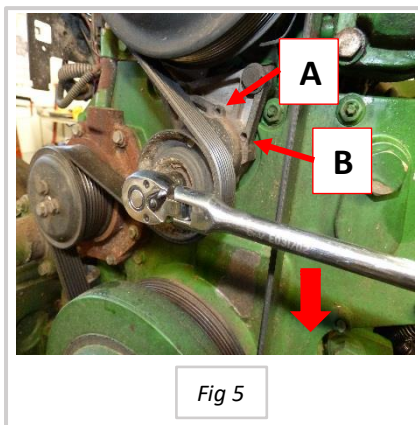
Fig 5

De-tension the belt by removing the dust cap in the centre of the pulley, with a 15mm socket (see arrow) on (Fig 5).

Rotate tensioner until the two locking holes A & B are aligned (Fig 5).

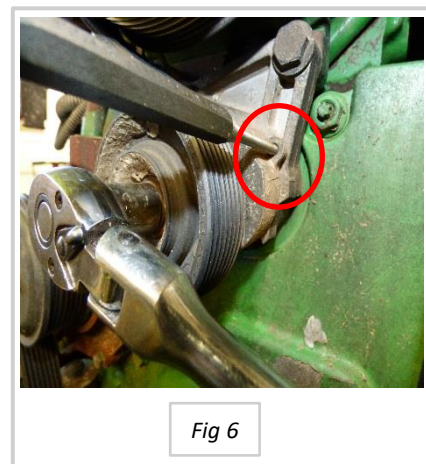
Fig 6

Once holes A & B are aligned insert a 5mm (0.2in.) diameter pin into the holes making sure you push the pin all the way through both holes to lock the tensioner (Fig 6) for this purpose we used a 5mm centre punch.

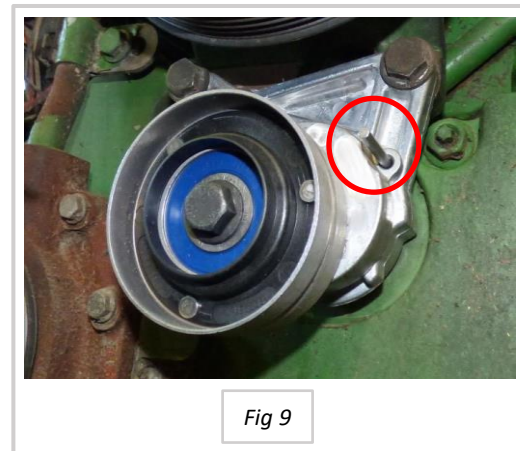
Fig 9

The tensioner is now ready to be replaced (*Fig 9*) this tensioner is held on with 3 M10X35 (10.9) bolts, undo the bolts and remove the tensioner, be careful the locking pin does not come out on removal as this could cause injury.

When fitting the new tensioner make sure the mounting surface where the back of the unit fits is clean and free from debris, bolt up the new tensioner (always refer to manufacturer manual for torque settings) be very careful **not to remove the pin** this will be done after belt installation.

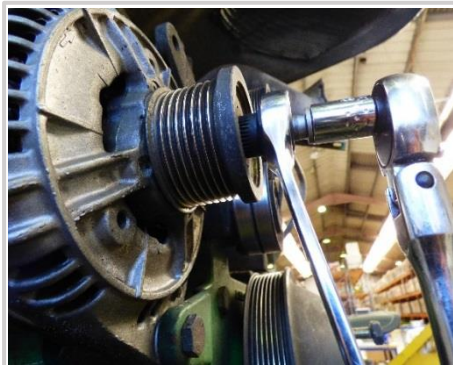
Fig 10

Next we replaced the Alternator OAP, to do this you will need a special tool (we can supply this, part number (400 0531 10) The OAP is threaded onto the alternator shaft, the tools internal spline holds the alternator shaft whilst the outer spline unwinds the OAP from the shaft. Using a spanner and socket ratchet undo (RH thread) the OAP (Fig 10), (for technical advice and diagnosis of OAP see Technical Bulletin TB1251.

Once the old OAP has been removed make sure the thread of the Alternator shaft is clean and undamaged, Fit the new OAP, remembering to use the special tool, (Torque to 85nm).

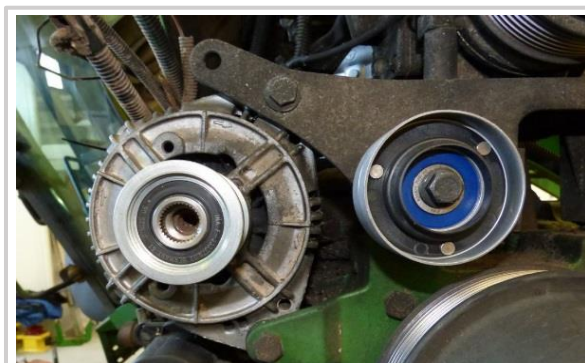
Fig 11

Now replace the idler (Fig11) to the right of the Alternator, (always refer to manufacturer manual for torque settings) this is a straight forward replacement but make sure the mounting surface where the back of the unit fits is clean and free from debris.

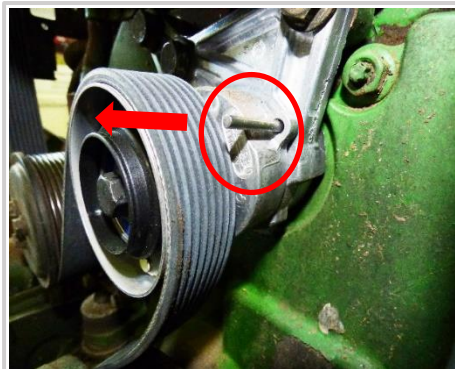
Fig 13

Once you have checked alignment and you have torqued all bolts, its time to tension the belt, to do this you need to turn tensioner using a 15mm socket to relieve the tension, you should now remove locking pin from tensioner (*Fig 13*), and then release gently.

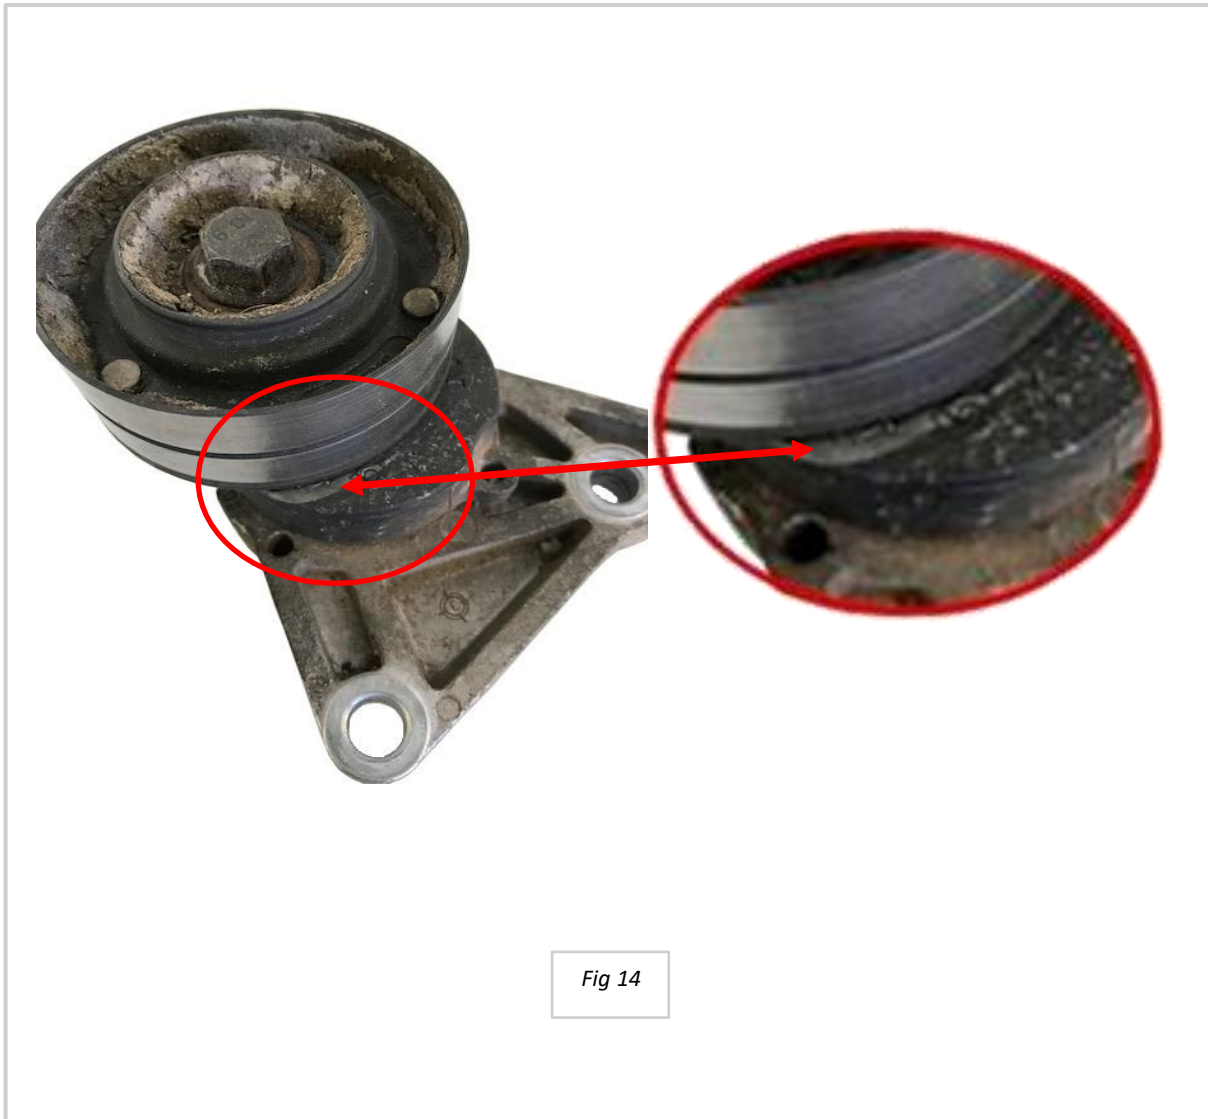
Fig 14

The belt replaced is of a unknown manufacture not a genuine belt, this looks like a recent replacement, and the date stamp means its approx. 1 year old it has all ready started to shows signs of miss alignment (we can highlight the wear pattern on the tensioner picture). There are signs of wear on the new Belt that are indicative of miss alignment.

Tensioner (*Fig 14*), we have replaced the Tensioner as part of the complete FEAD Kit, INA always recommend to replace complete sets, we have circled the miss alignment wear mark the belt has made on the body of the tensioner next to idler wheel.
