# SERVICE - INFO

**LuK Nr: 128 0055 11 – 280mm DBVR**

**Bulletin 988 2000 960**

**CASE IH, MANITOU, VOLVO\*\***

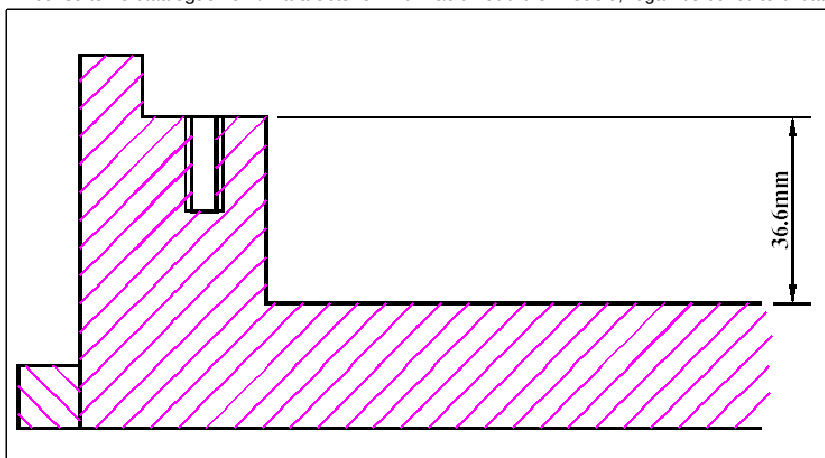
**Flywheel  
Schwungrad  
Volant-moteur  
Volante-motor  
Volano**

| <b>(GB)</b> | Please ensure that the flywheel is machined to a pot depth of 36.6mm. |

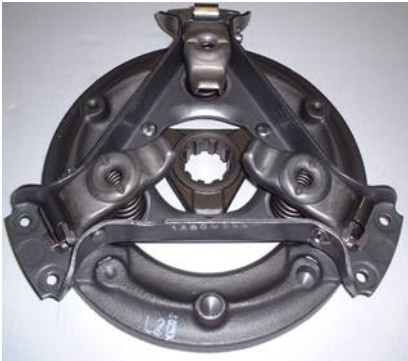
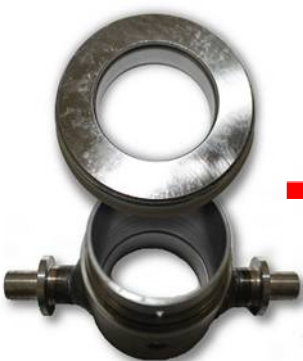
| Info: | Fig 2 replaces / ersetzt / remplace / sustituye a / sostituisce Fig 1 |

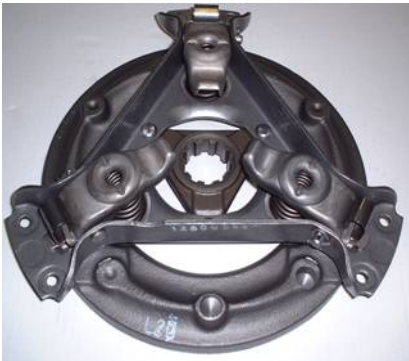
| Info: | Fig 4 replaces / ersetzt / remplace / sustituye a / sostituisce Fig 3 |
