# SERVICE - INFO

**LuK Nr: 128 0055 11 – 280mm DBVR**

**Bulletin 988 2000 960**

**CASE IH, MANITOU, VOLVO\*\***

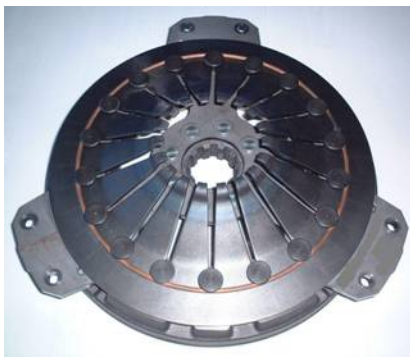
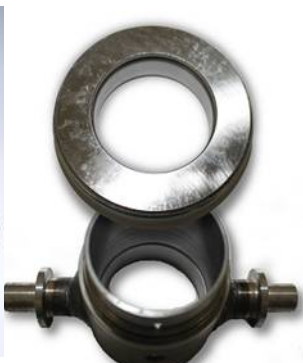
| Info: | Fig 2 replaces / ersetzt / remplace / sustituye a / sostituisce Fig 1 |

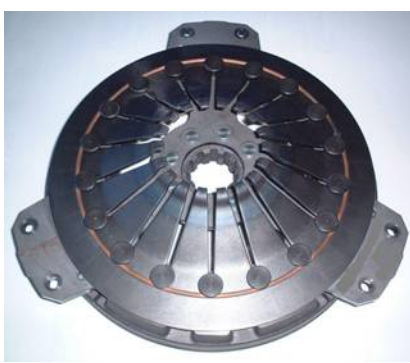
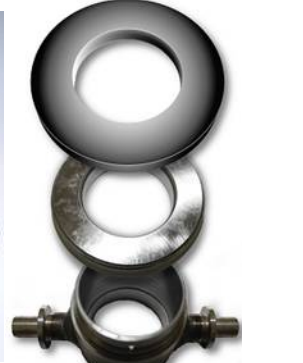
OPTIONAL / WAHLWEISE / OPTIONNEL / OPCIONAL / OPTIONAL

| Info: | Fig 4 replaces / ersetzt / remplace / sustituye a / sostituisce Fig 3 |
