# SERVICE - INFO

**LuK Nr: 128 0055 11 – 280mm DBVR**

**Bulletin 988 2000 960**

**CASE IH, MANITOU, VOLVO\*\***

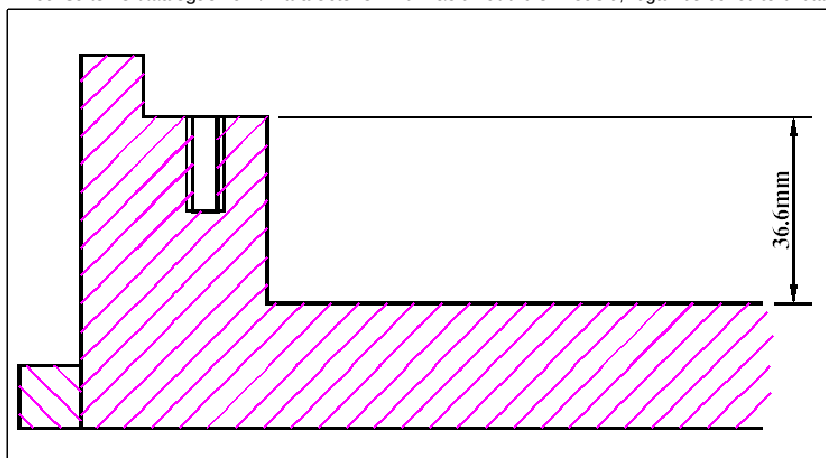
**Flywheel  
Schwungrad  
Volant-moteur  
Volante-motor  
Volano**

| <b>(GB)</b> | Please ensure that the flywheel is machined to a pot depth of 36.6mm. |

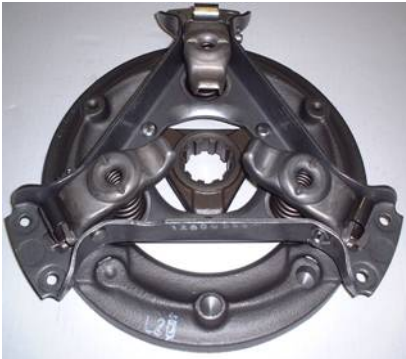
| Info: | Fig 2 replaces / ersetzt / remplace / sustituye a / sostituisce Fig 1 |

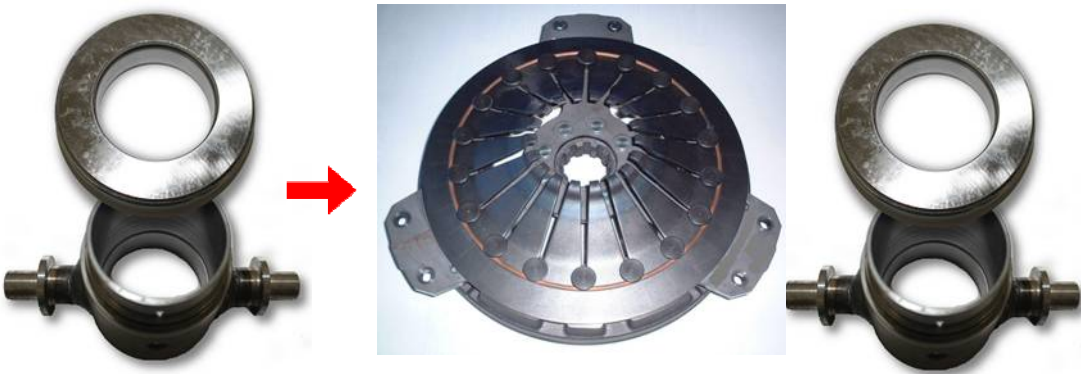
Fig 2

OPTIONAL / WAHLWEISE / OPTIONNEL / OPCIONAL / OPTIONAL

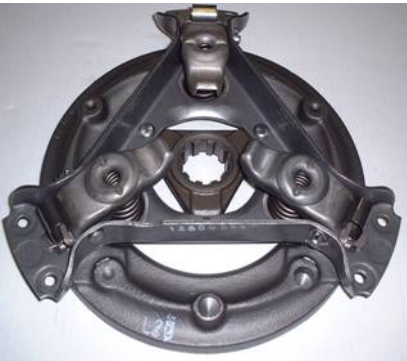
| Info: | Fig 4 replaces / ersetzt / remplace / sustituye a / sostituisce Fig 3 |
