TRACTOR SERVICE INFO

INATractor FEAD clinic – John Deere 6520

FEAD belt kit replacement – step by step

This John Deere 6520 produced in 2004 has just over 8000 working hours.

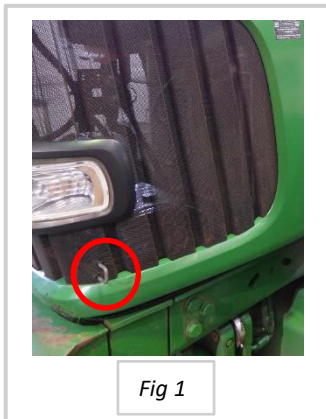
Fig 1

Pull the catch and lift the hood up (*Fig 1*).

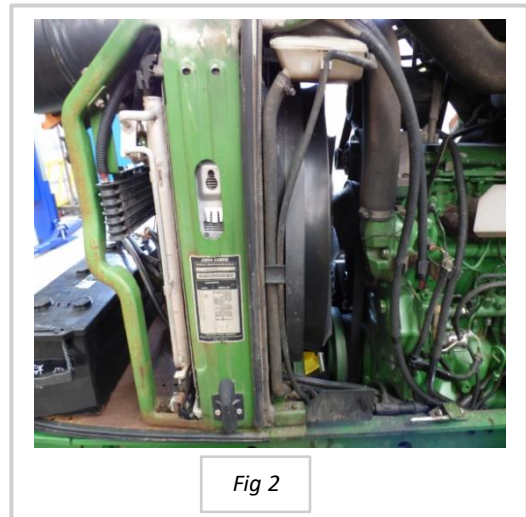
Fig 2

We have also removed the radiator and casings to enable us to photograph the replacement (*Fig 2*).

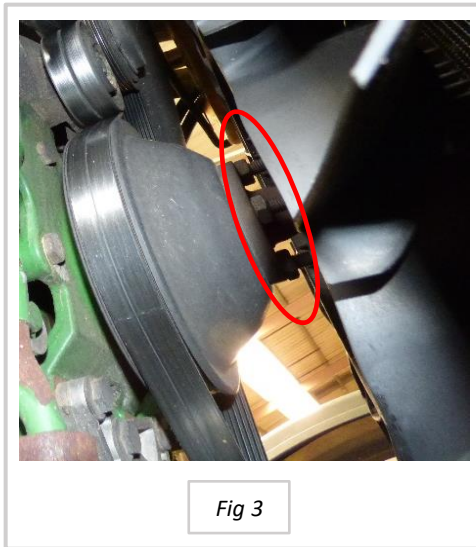
Fig 3

Remove retaining nuts (Fig 3) holding the viscous fan (Fig 4) for access to the drive belt and other sundries (Tensioners, Idlers & OAP's).

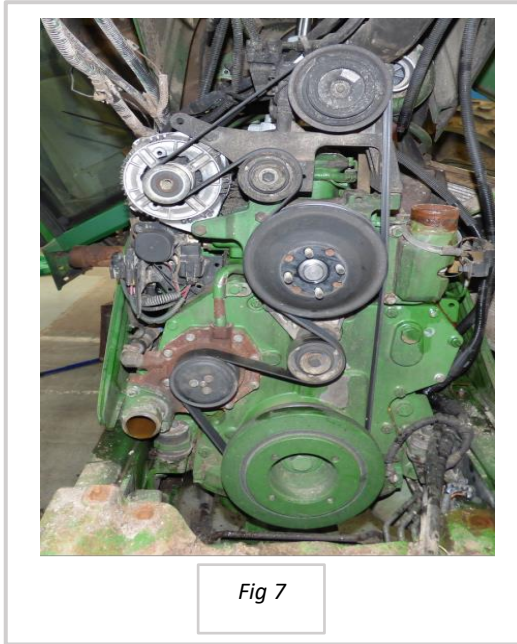
Fig 7

The belt can now be removed (*Fig 7&8*)

The belt replaced is of a unknown manufacture not a genuine belt, this looks like a recent replacement, and the date stamp means its approx. 1 year old it has all ready started to shows signs of miss alignment (we can highlight the wear pattern on the tensioner picture). There are signs of wear on the new Belt that are indicative of miss alignment.

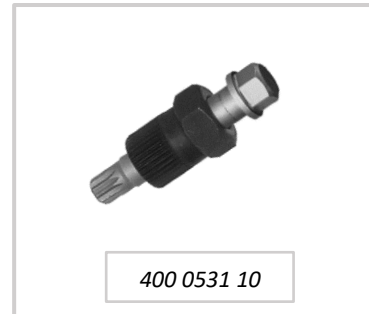
400 0531 10

Next we replaced the Alternator OAP, to do this you will need a special tool (we can supply this, part number (400 0531 10) The OAP is threaded onto the alternator shaft, the tools internal spline holds the alternator shaft whilst the outer spline unwinds the OAP from the shaft. Using a spanner and socket ratchet undo (RH thread) the OAP (Fig 10), (for technical advice and diagnosis of OAP see Technical Bulletin TB1251.

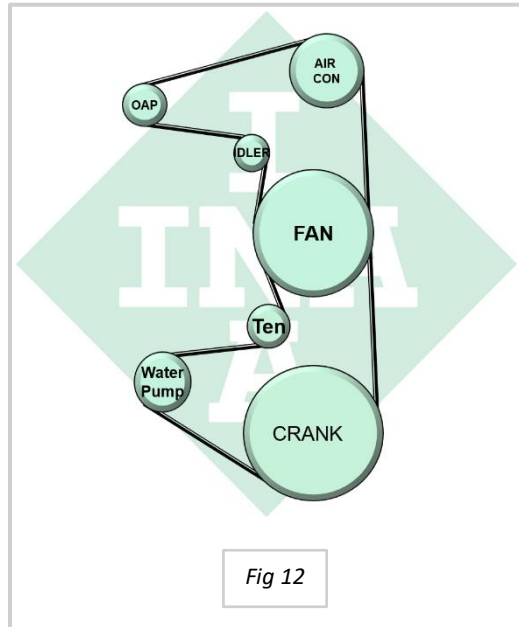
The new belt can now be fitted, following the correct belt routing (*Fig 12*).

After belt fitment always make sure that the belt and any sundries that have been replaced are all aligned correctly, there are special tools available to test alignment and we always recommend using them.
