# SERVICE - INFO

**LuK Nr: 128 0055 11 – 280mm DBVR**

**Bulletin 988 2000 960**

**CASE IH, MANITOU, VOLVO\*\***

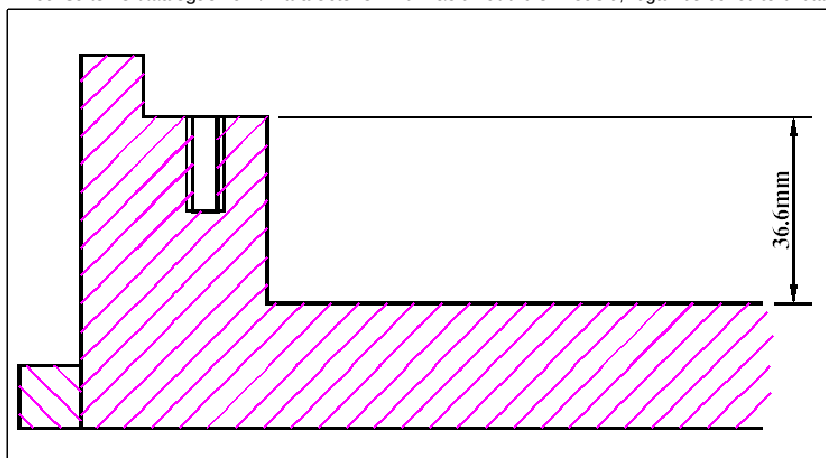
**Flywheel  
Schwungrad  
Volant-moteur  
Volante-motor  
Volano**

| <b>(GB)</b> | Please ensure that the flywheel is machined to a pot depth of 36.6mm. |

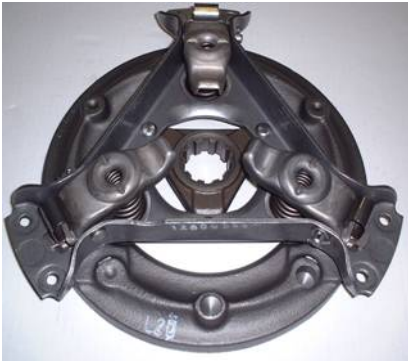
| Info: | Fig 2 replaces / ersetzt / remplace / sustituye a / sostituisce Fig 1 |

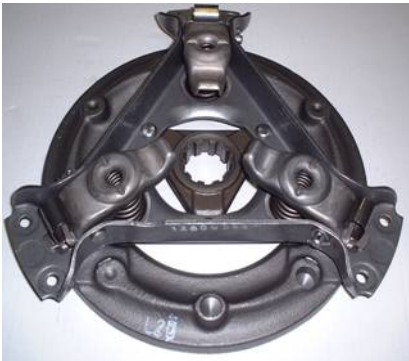
| Info: | Fig 4 replaces / ersetzt / remplace / sustituye a / sostituisce Fig 3 |

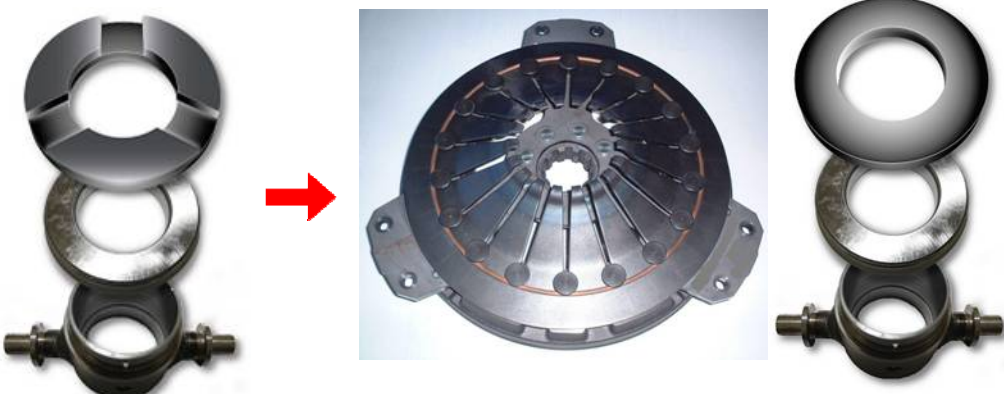
Fig 4

OPTIONAL / WAHLWEISE / OPTIONNEL / OPCIONAL / OPTIONAL
