## LuK Nr: 128 0055 11 – 280mm DBVR

Bulletin 988 2000 960

CASE IH, MANITOU, VOLVO\*\*

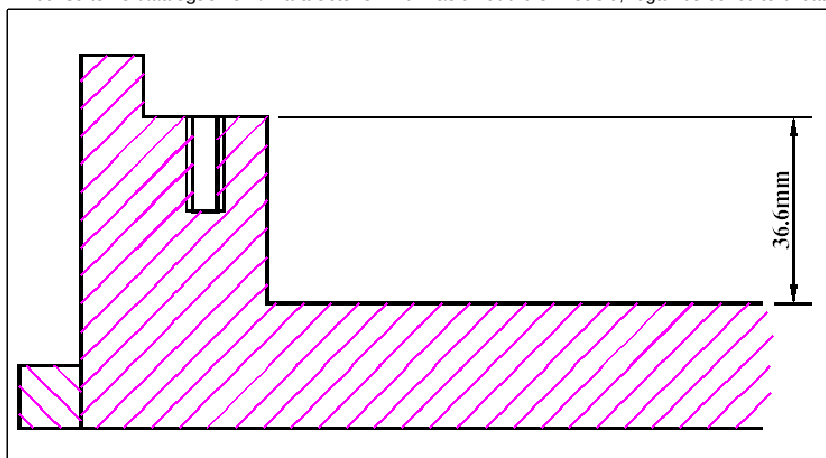
Flywheel  
 Schwungrad  
 Volant-moteur  
 Volante-motor  
 Volano

| <b>(GB)</b> | Please ensure that the flywheel is machined to a pot depth of 36.6mm. |

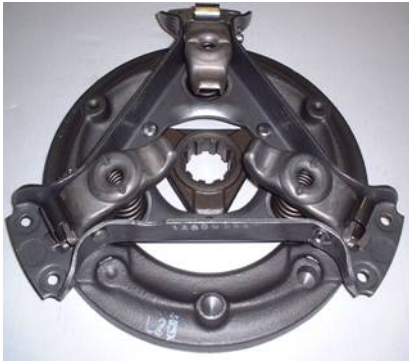
| Info: | Fig 2 replaces / ersetzt / remplace / sustituye a / sostituisce Fig 1 |

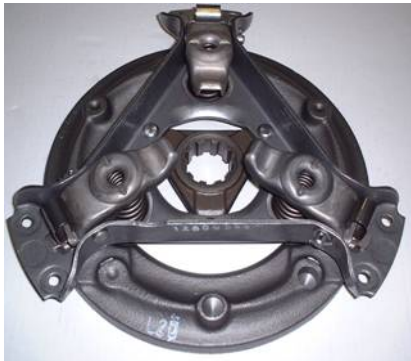
| Info: | Fig 4 replaces / ersetzt / remplace / sustituye a / sostituisce Fig 3 |
