# SERVICE - INFO

**LuK Nr: 128 0055 11 – 280mm DBVR**

**Bulletin 988 2000 960**

**CASE IH, MANITOU, VOLVO\*\***

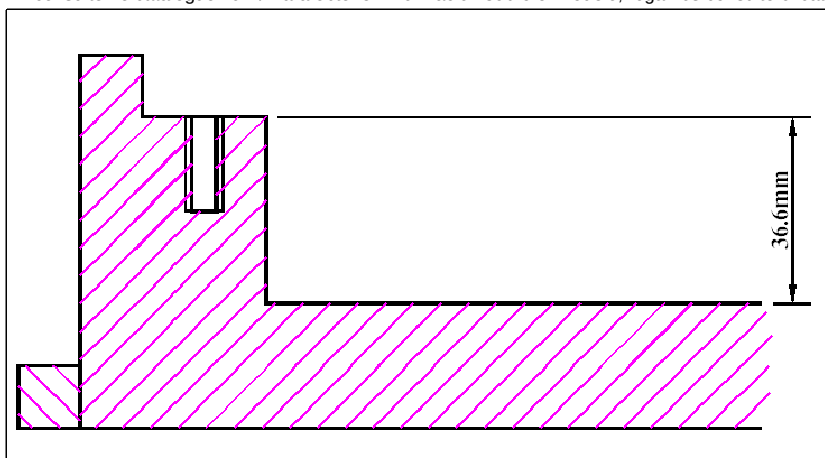
**Flywheel  
Schwungrad  
Volant-moteur  
Volante-motor  
Volano**

| <b>(GB)</b> | Please ensure that the flywheel is machined to a pot depth of 36.6mm. |

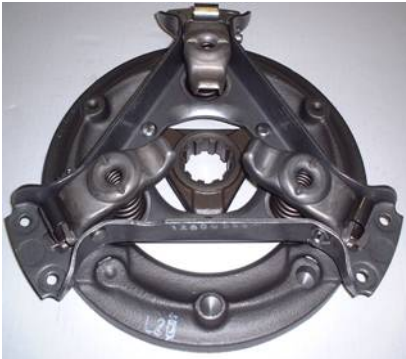
| Info: | Fig 2 replaces / ersetzt / remplace / sustituye a / sostituisce Fig 1 |

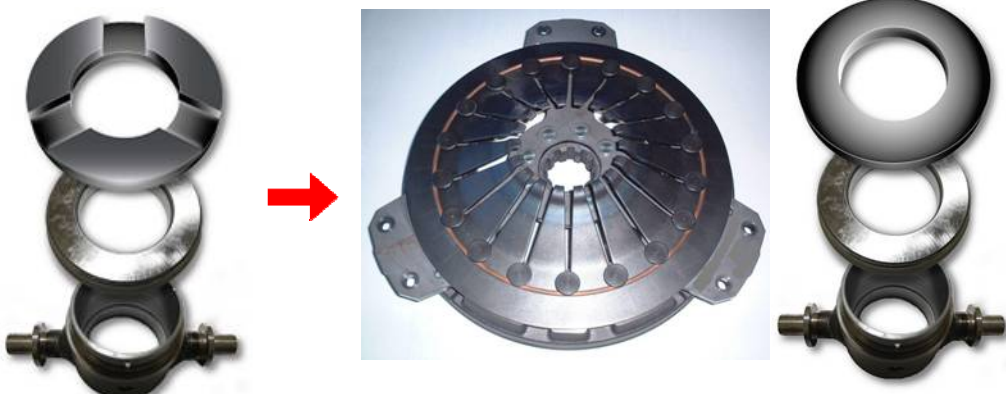
OPTIONAL / WAHLWEISE / OPTIONNEL / OPCIONAL / OPTIONAL

| Info: | Fig 4 replaces / ersetzt / remplace / sustituye a / sostituisce Fig 3 |
