SERVICE - INFO

LuK Nr: 128 0055 11 – 280mm DBVR

Bulletin 988 2000 960

CASE IH, MANITOU, VOLVO**

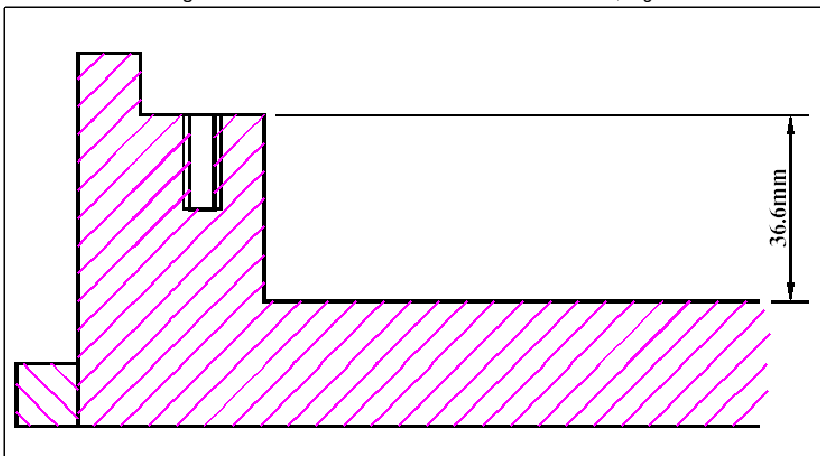
**Flywheel
Schwungrad
Volant-moteur
Volante-motor
Volano**

Info:	128 0055 11 replaces / ersetzt / remplace / sustituye a / sostituisce 128 0055 40 + 128 0055 41
(GB)	Please ensure that the flywheel is machined to a pot depth of 36.6mm.

(D)	Das Schwungrad ist auf eine Tiefe von 36.6mm auszdrehen,siehe unten.
(F)	Veuillez vous assurer que le volant-moteur est rectifié à une profondeur de 36.6mm.

(E)	Asegúrese de que el volante está mecanizado hasta una profundidad de 36.6mm.
(I)	Controllare che il volano venga rettificato a una profondità di 36.6mm.
LuK Repsets:	628 1032 07 = 128 0055 11 + 328 0175 42 + 500 1046 50 + 410 0026 00 628 1032 09 = 128 0055 11 + 328 0175 42 628 1033 07 = 128 0055 11 + 328 0175 41 + 500 1046 50 + 410 0026 00 628 1033 09 = 128 0055 11 + 328 0175 41 628 2590 07 = 128 0055 11 + 328 0175 40 + 500 1046 50 + 410 0026 00 628 2590 09 = 128 0055 11 + 328 0175 40 628 2592 07 = 128 0055 11 + 328 0175 10 + 500 1046 50 + 410 0026 00 628 2592 09 = 128 0055 11 + 328 0175 10
	128 0055 11 – 128 0055 12 + 434 0342 10

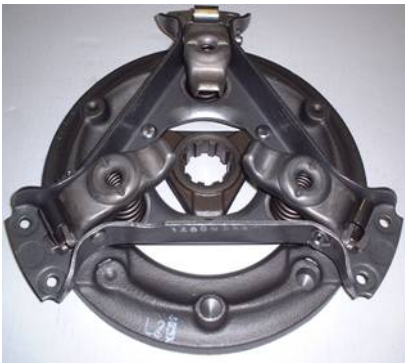
Fig 2 replaces / ersetzt / remplace / sustituye a / sostituisce Fig 1

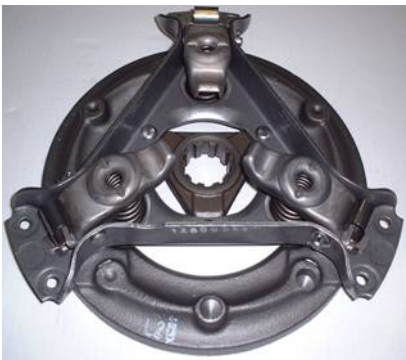
Fig 4 replaces / ersetzt / remplace / sustituye a / sostituisce Fig 3
