LuK Nr: 128 0055 11 – 280mm DBVR

Bulletin 988 2000 960

CASE IH, MANITOU, VOLVO**

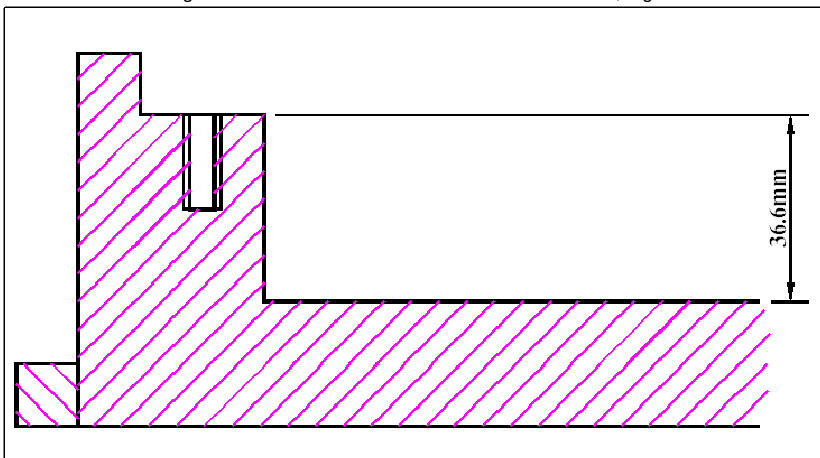
**Flywheel
Schwungrad
Volant-moteur
Volante-motor
Volano**

Info:	128 0055 11 replaces / ersetzt / remplace / sustituye a / sostituisce 128 0055 40 + 128 0055 41
(GB)	Please ensure that the flywheel is machined to a pot depth of 36.6mm.

(D)	Das Schwungrad ist auf eine Tiefe von 36.6mm auszdrehen,siehe unten.
(F)	Veillez vous assurer que le volant-moteur est rectifié à une profondeur de 36.6mm.

(E)	Asegúrese de que el volante está mecanizado hasta una profundidad de 36.6mm.
(I)	Controllare che il volano venga rettificato a una profondità di 36.6mm.
LuK Repsets:	628 1032 07 = 128 0055 11 + 328 0175 42 + 500 1046 50 + 410 0026 00 628 1032 09 = 128 0055 11 + 328 0175 42 628 1033 07 = 128 0055 11 + 328 0175 41 + 500 1046 50 + 410 0026 00 628 1033 09 = 128 0055 11 + 328 0175 41 628 2590 07 = 128 0055 11 + 328 0175 40 + 500 1046 50 + 410 0026 00 628 2590 09 = 128 0055 11 + 328 0175 40 628 2592 07 = 128 0055 11 + 328 0175 10 + 500 1046 50 + 410 0026 00 628 2592 09 = 128 0055 11 + 328 0175 10
	128 0055 11 – 128 0055 12 + 434 0342 10

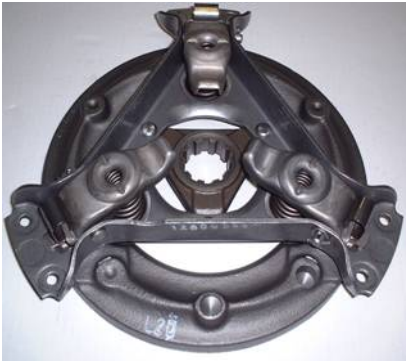
Info: Fig 2 replaces / ersetzt / remplace / sustituye a / sostituisce Fig 1

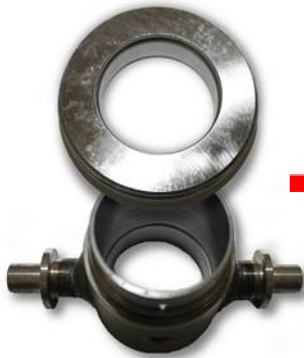
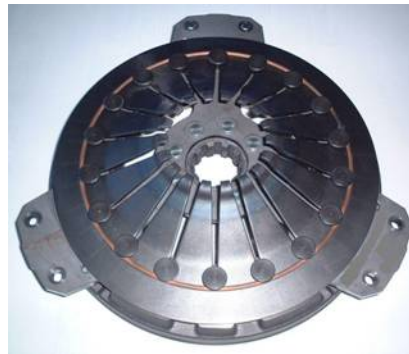
Fig 2

OPTIONAL / WAHLWEISE / OPTIONNEL / OPCIONAL / OPTIONAL

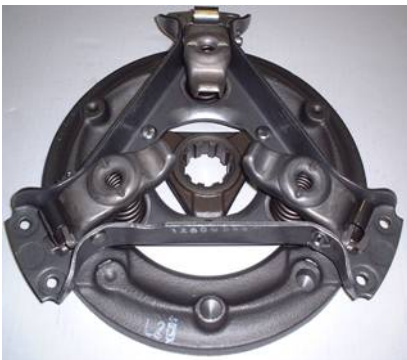
Info: Fig 4 replaces / ersetzt / remplace / sustituye a / sostituisce Fig 3
